# Manhole Inspection Summary

Manhole # S19II\_031MH

**Location** Address: **1654 SAMLLWOOD ST** Cross Street: **PRESBURY ST**

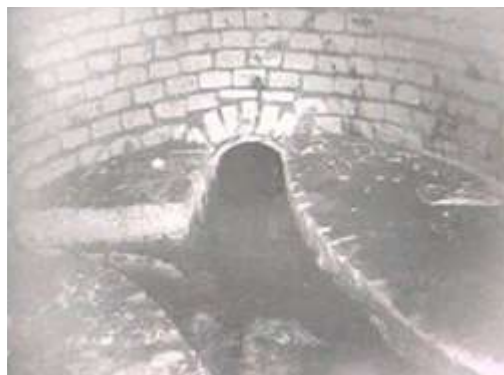
Top View

Comments **DUE TO CONSTRUCTION OF MANHOLE AND MISSING STEPS, COULD NOT GET AN ACCURATE TOP VIEW AS REQUESTED. S SHAPED CHANNEL IS ELONGATED AND WILL NOT FIT IN FRAME OF PHOTO. REWORK COMPLETED AS BEST AS POSSIBLE. 3-12-09**

6 OCLOCK ON LEFT, 9 OCLOCK IN CENTER

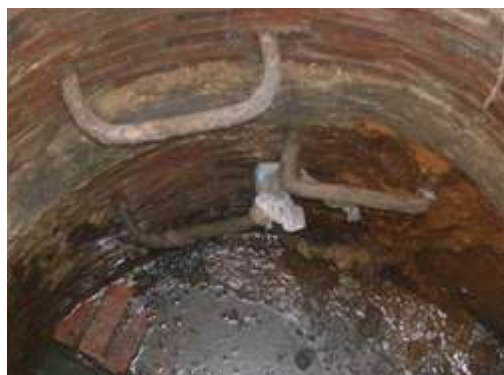
Defect 3

**Surcharge** ☒ **Evidence Of Surcharge** Depth: **4** (ft.) ☐ Active Surcharge Present

EVIDENCE OF SURCHARGE ON THE STEPS

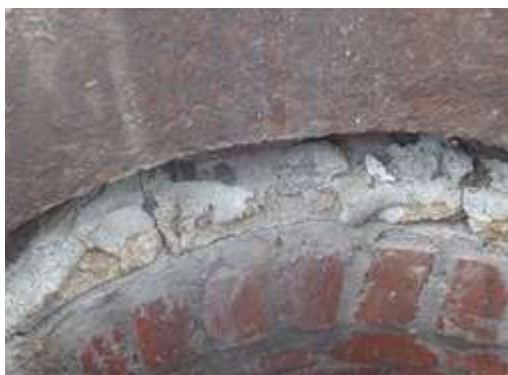
Defect 2

**Chimney / Frame Adjustment** ☒ Exists Material: **Brick and Concrete** ☐ Parged Height: **6** (in.)  
Condition: ☐ Sound ☐ Cracked ☐ Root Intrusion ☐ Loose Brick ☒ **Deteriorated**  
Infiltration: ☒ None ☐ Joint ☐ Cracks ☐ Mortar ☐ Roots ☐ Wall

DETERIORATION OF THE CHIMNEY

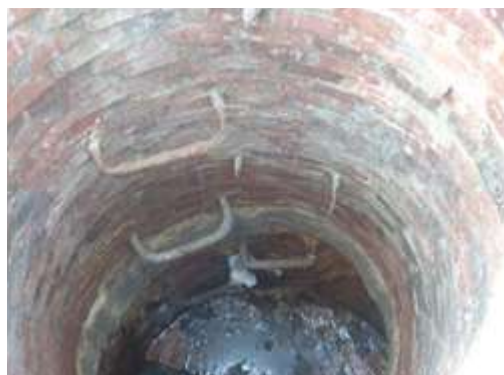
Defect 1

**Steps** Count: **4** Missing: **3** ☒ **Corroded**

STEPS ARE CORRODED AND SOME ARE MISSING

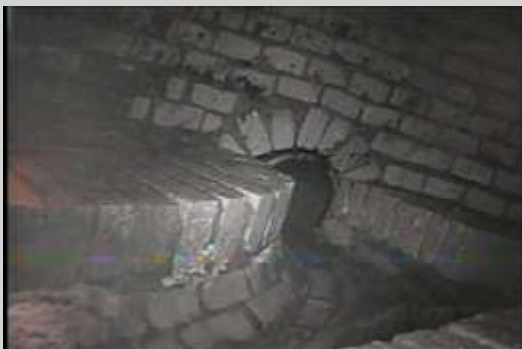
6 O'Clock Inflow

8 in. Circular Gravity Sewer  
Pipe In @ 6 O'Clock

Pipe Height: **7.2** (in.) Rod and Bar (Angled)  
Pipe Material: **Clay** ☐ Pipe Lined  
Invert Depth: **12.53** (ft.) Flow Characteristics: **Fast**  
Deposits: ☒ None ☐ Mud ☐ Sludge ☐ Debris ☐ Grease  
Silt Depth: (in.) Deposits Extent:  
Infiltration: **None** Pipe Seal Cond: **Broken**
